*Environmental Friendly Mining Best Practices for Concessions around Gishwati, part of  
the Gishwati-Mukura National Park (GMNP)*

***FINAL REPORT***

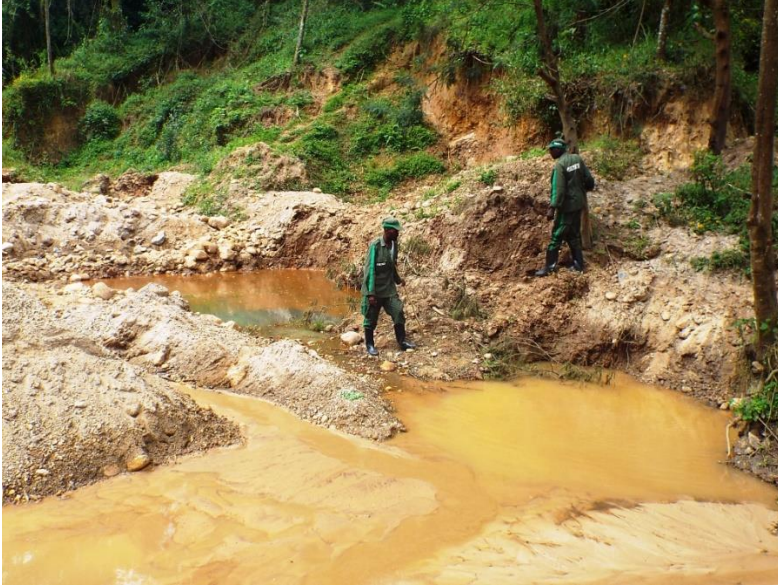
Figure 3: Landscape degradation and silted river by mining activities, Nduruma site, inside Gishwati forest

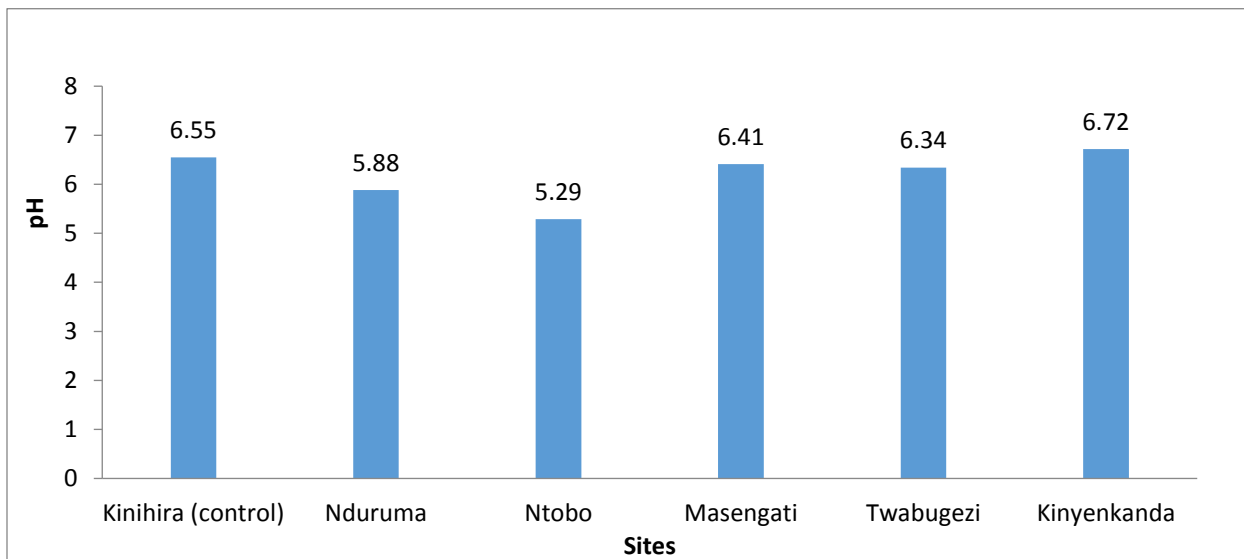
Figure 5 : pH values of sampled sites

The figure above depicts that pH values of sampled water vary between 5.29 and 6.72 which make them to be slightly acid but near to the neutral. Apart from the water collected from Ntobo site with pH (5.29) falling into group C of the NGVDW (Low health risk) and Nduruma falling into group B (acceptable quality), the remaining sites have pH oscillating between 6.34 and 6.72 which falls into group A of the NGVDW (excellent quality). The pH values show that the stream/river water from mining sites is still having a good quality in general. However, there is a need to put a special attention and control on the quality of water in two sites namely Ntobo and Nduruma to

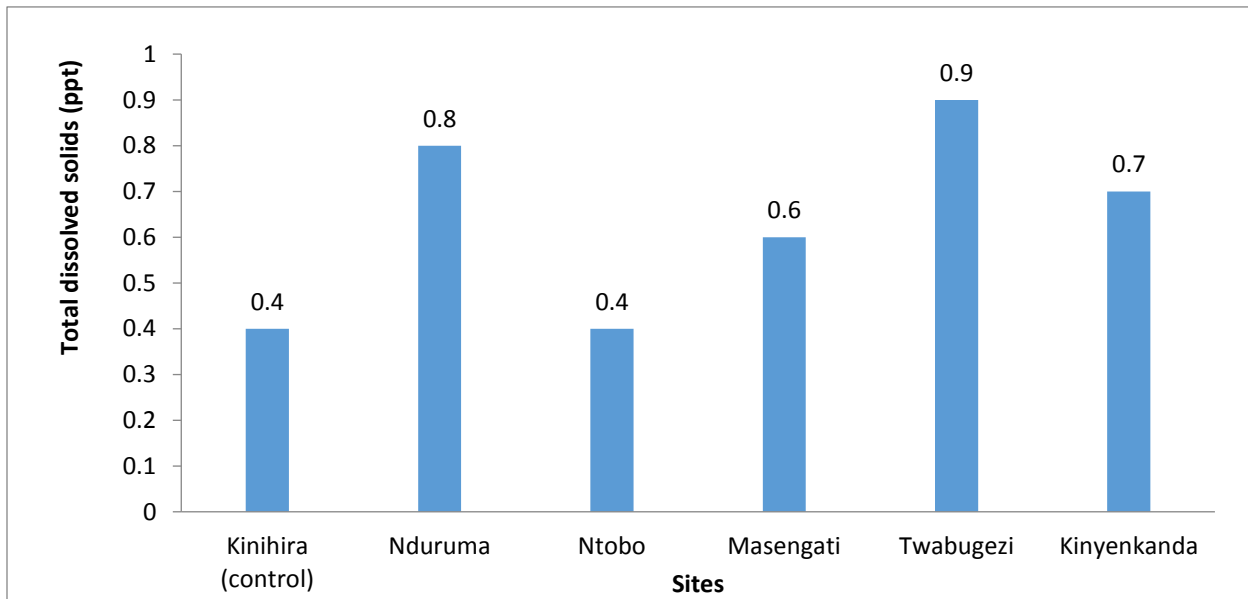
Figure 8: Total Dissolved Solids (ppt) at sampled sites

The measured TDS in the water ranges between 0.4 and 0.9 ppt. At Ntobo site, TDS is the same rate as the water collected from Kinihira (control site) which implies the absence of influence of mining activities on this site. However, more influence of mining on solid dissolution in the water is observed at Twabugezi and Nduruma with 0.9 and 0.8 ppt respectively. These values are higher than 0.5 ppt (or 500 ppm) fixed by Bureau of Indian Standards (BIS) as the upper limit of TDS for

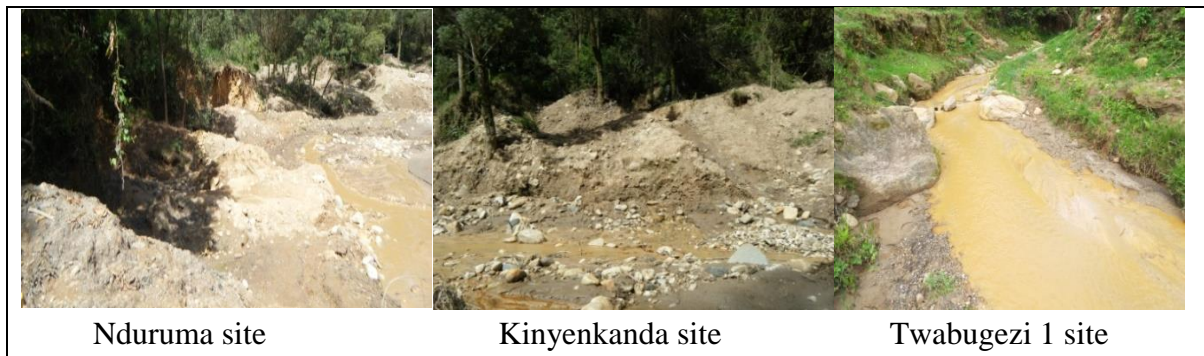
Figure 10: A photograph showing the water turbidity at selected sites

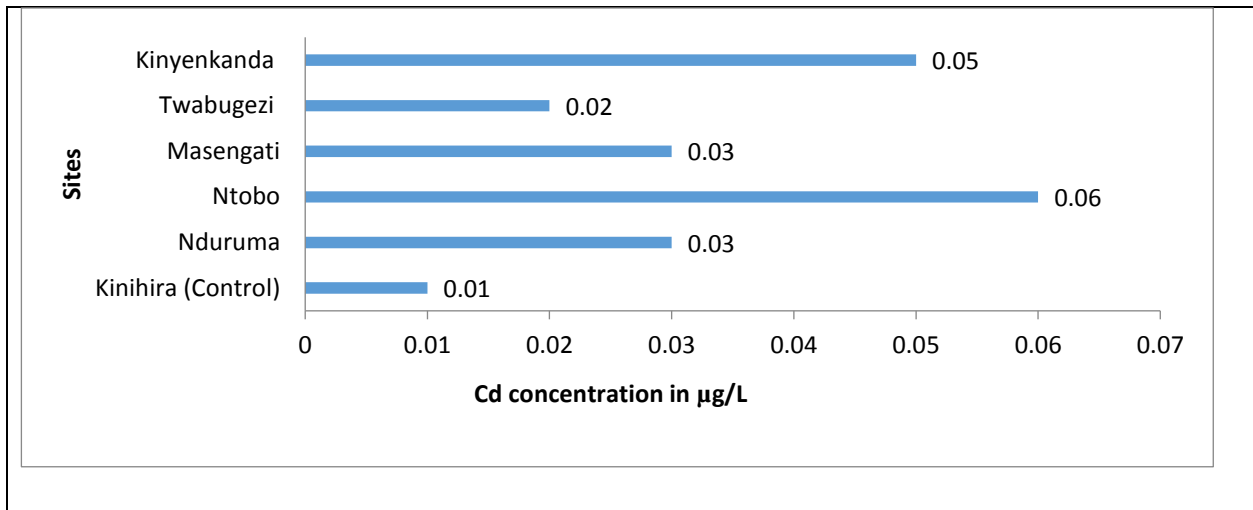
Figure 11: Concentration of Arsenic and Cd at study area

The Arsenic (As) concentration and Cadmium (Cd) vary between 0.9 – 16.22 and 0.01 – 0.06  $\mu\text{g/L}$  respectively. Both As and Cd concentrations at all sampled sites fall in group A of DNGVDW (Excellent quality) as far as the measured Arsenic and Cadmium values are under 100  $\mu\text{g/l}$  and 10  $\mu\text{g/L}$  respectively. However, the measured values of arsenic from mining sites (between 1.72  $\mu\text{g/l}$  - 16.22  $\mu\text{g/L}$ ) are higher than the value of 0.9  $\mu\text{g/L}$  obtained from control area (Kinyihira). The same applies for Cadmium because the lowest value (0.01  $\mu\text{g/L}$ ) was measured from control site (Kinyihira). It is important noting that Ntobo site have the highest values of both Arsenic and Cadmium followed by Kinyenkanda. All these confirm the contribution of mining activities in increasing the quantity of As and Cd in the study area. Animals, especially small mammals and birds living in Gishwati forest will likely uptake these toxic elements while drinking the water. On long term, these elements will accumulate in their body which will negatively affects physiological processes and reproduction, hence increased morbidity and progressive reduction of this animal population size.

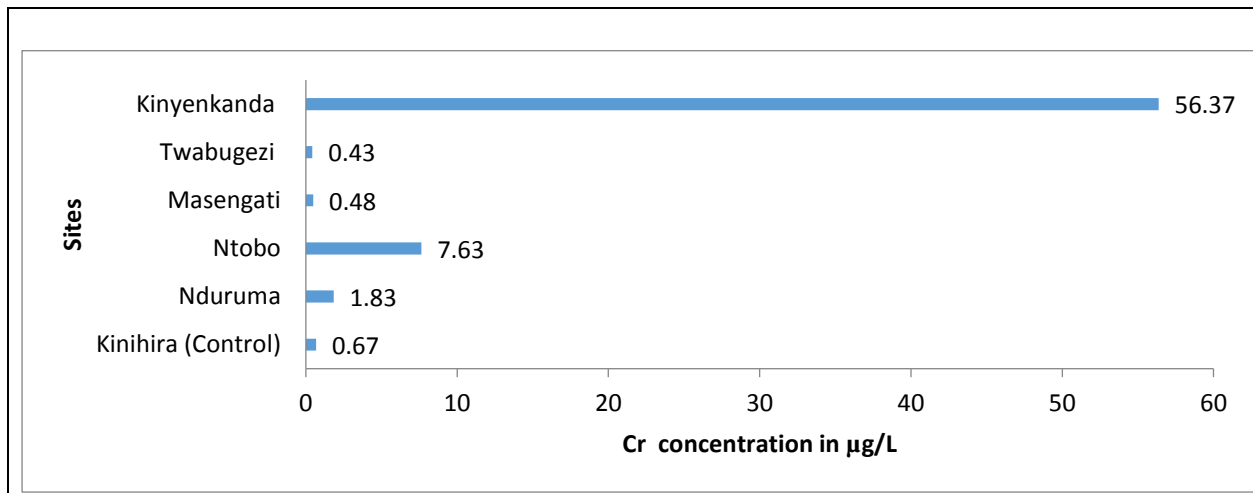
Figure 12: Concentration of Cr and Cu at study area

The Cr concentration is highly varying at study area as it is increasing from 0.43 at Twabugezi 1 site to 0.48 µg/L at Masengeti to become 1.83 µg/L at Nduruma and 7.63 µg/L at Ntobo to culminate to 56.37 µg/L at Kinyenkanda. Cr concentration (0.67 µg/l) at control area of Kinyihira is closer to that of Masengeti. Kinyenkanda site which showed a very high concentration of Cr has the lowest Cu concentration of 2.88 µg/L followed by the control area (Kinyihira) with 3.77 while the highest concentration of 6.71 µg/L was seen at Twabugezi. These concentrations are very low to 500 µg/L minimum standard concentrations provided by NGVDW and show the excellent quality of water in terms of its copper concentration but a special attention is to be focused to the site of Twabugezi for Cu and Kinyenkanda for Cr.

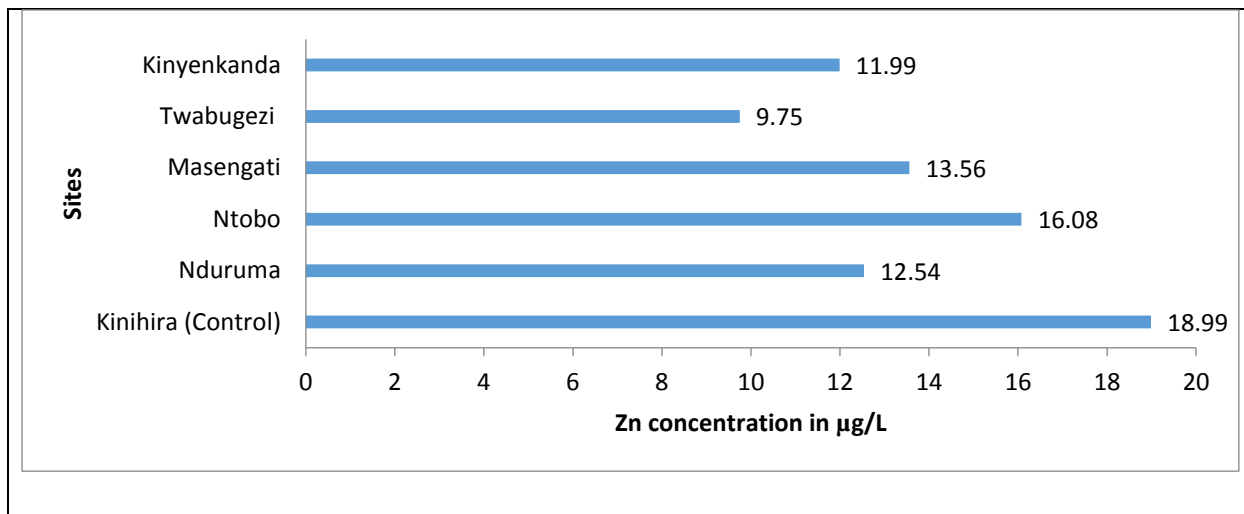
Figure 13: Concentration of Pb and Zn in sampled water

Lead (Pb) concentrations at the study area vary between 0.12 µg/L at control area (Kinihira) and 0.24 µg/L at Kinyenkanda. It was evaluated at 0.12 µg/L, 0.15 µg/L, 0.17 µg/L and 0.19 µg/L for Kinyenkanda, Twabugezi, Nduruma and Ntobo sites respectively and it raised to 0.2 µg/L and 0.24 µg/L at Masengati and Kinyenkanda respectively. This means that there is no significant difference between control area (Kinihira) and the mining areas as far as the highest range in Pb concentration is only 0.12 µg/L. Furthermore, Pb concentration at all sampled sites is very low to 50 µg/L considered as minimum acceptable concentration for drinking water. Hence, the measured Pb concentration at control area and mining areas is not yet harmful to the plant and animal life. For Zinc concentration, Twabugezi 1 with 9.75 µg/L is the only site with less than 10 µg/L, the remaining sites have the values between 11.99 µg/L and 18.99 µg/L which fall under Group A of DNGVDW (Excellent quality). Surprisingly the control site (Kinihira) has the highest concentration (18.99 µg/L) of Zinc (Table 7). This means that Zinc concentration in mining tailing tend to be lower at sampled sites. This suggests that mining activities did not play relevant role in enriching Zinc in water.

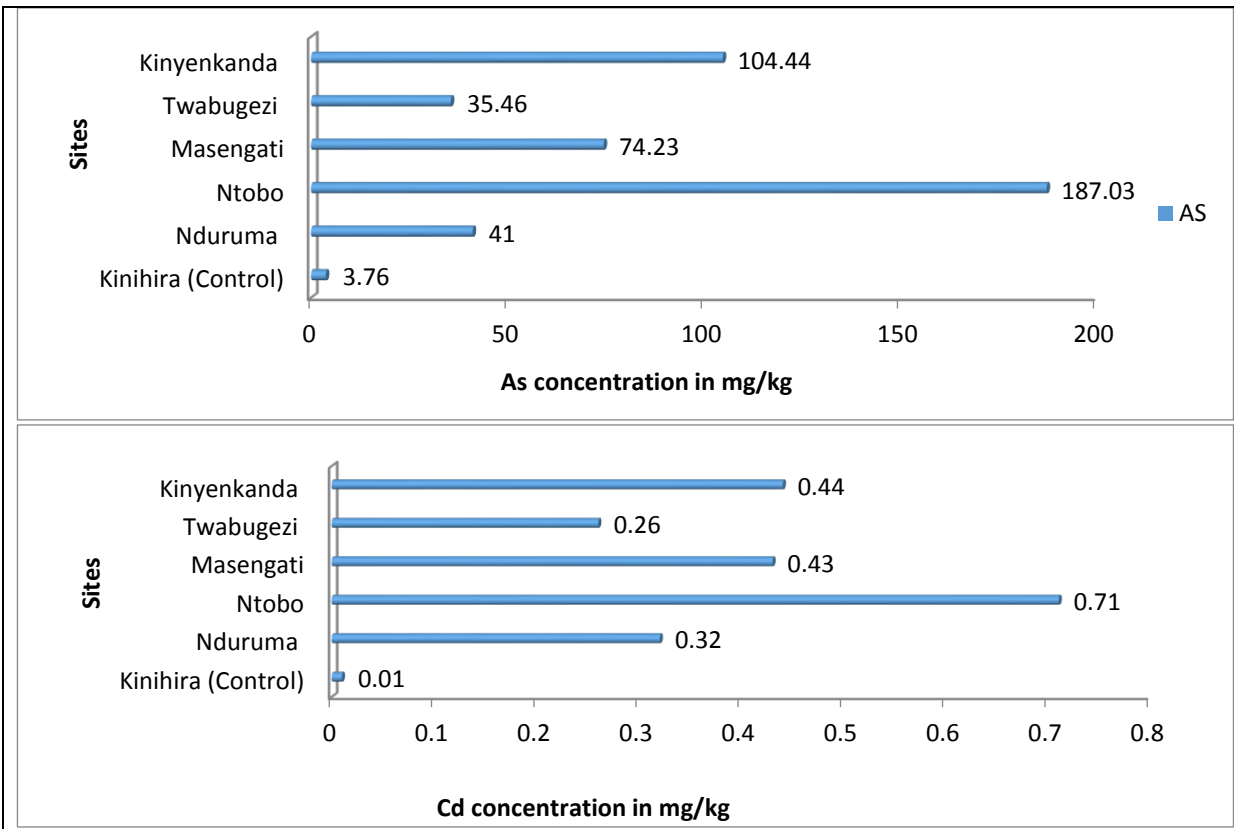
The figures below shows the concentration of Arsenic (As) and Cadmium (Cd) in the soil. For As, compared to the control site, all the five mining sites present a high concentration of arsenic. The highest concentration is at Ntobo (187.3 mg/kg) followed by Kinyenkanda (104.44 mg/kg) while the lowest concentrations are respectively observable at Twabugezi (35.46 mg/kg) and Nduruma (41 mg/kg) sites. This concentration is above the global standard (30 mg/kg) and Austria and Germany standards (50 mg/kg), (Table 5). Therefore, all the five sites are affected and mostly Ntobo and Kinyenkanda. It important to note that higher concentration increases toxicity to

Figure 14: Arsenic (As) and cadmium (Cd) concentration in the sampled sites

Compared to the control site of Kinyihira with 0.01 mg/kg, the Cd concentrations show a high concentration at all sites, with the highest value at Ntobo site. This shows that the mining activities increase Cd in the soil referring to the Cd concentrations measured from all the five sites. However, all measurements, including Ntobo site, are still low compared to the selected allowable standards Cd concentrations in the soil that are 10 mg/kg for Canada, 20 for Germany, 5 for Austria, 3 for Europe and the global average of 2.7 mg/kg.

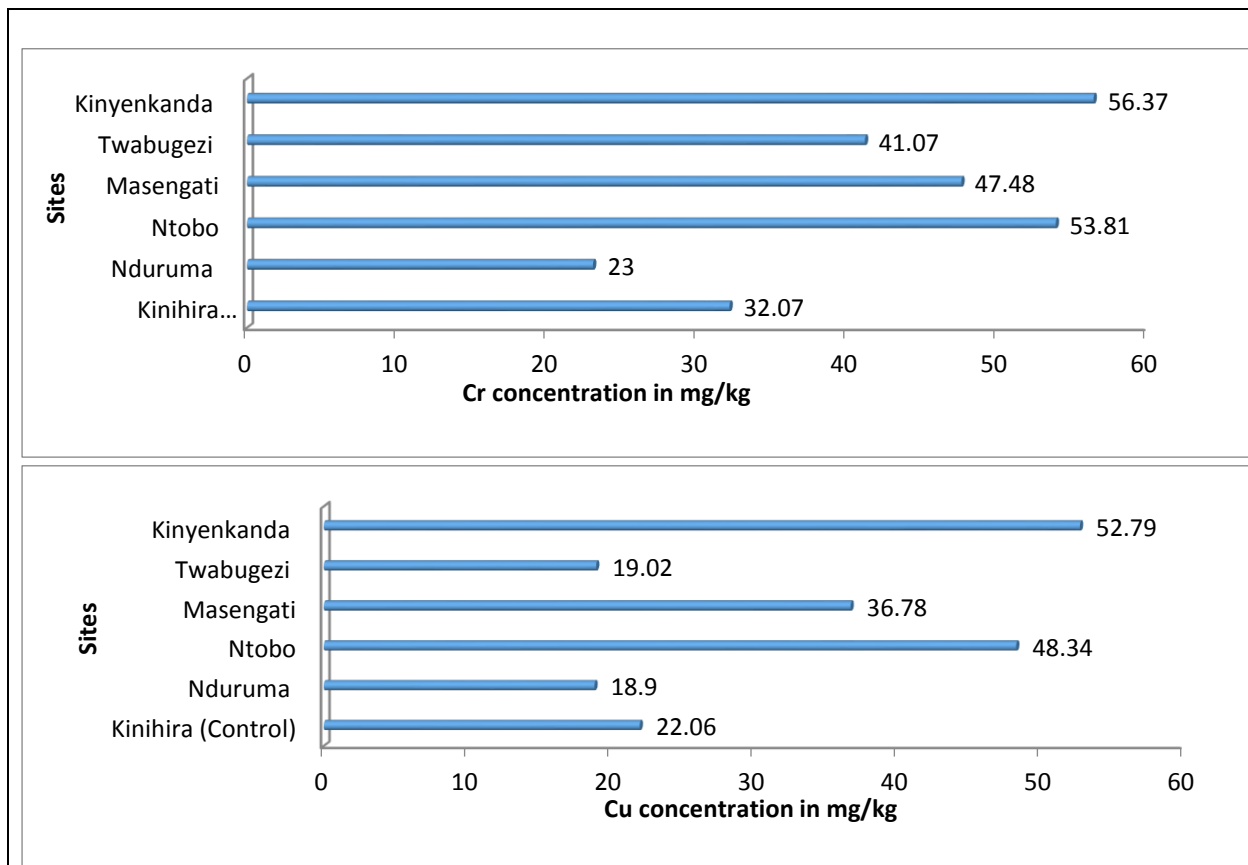
Figure 15: Chromium (Cr) and Copper (Cu) concentration in the sampled sites

The four sites, Kinyenkanda, Ntobo, Masengati and Twabugezi have respectively and in descending order the concentration values that are above the control (32.07 mg/kg); and that can be perceived as an impact of mining activities. The concentration is only below at the site of Nduruma. However, as it is the case of cadmium, all measurements are below the selected minimum acceptable standards of Germany (350 mg/kg), Austria (100 mg/kg), Europe (150 mg/kg) and Worldwide (530 mg/kg). Therefore, the effect is still manageable.

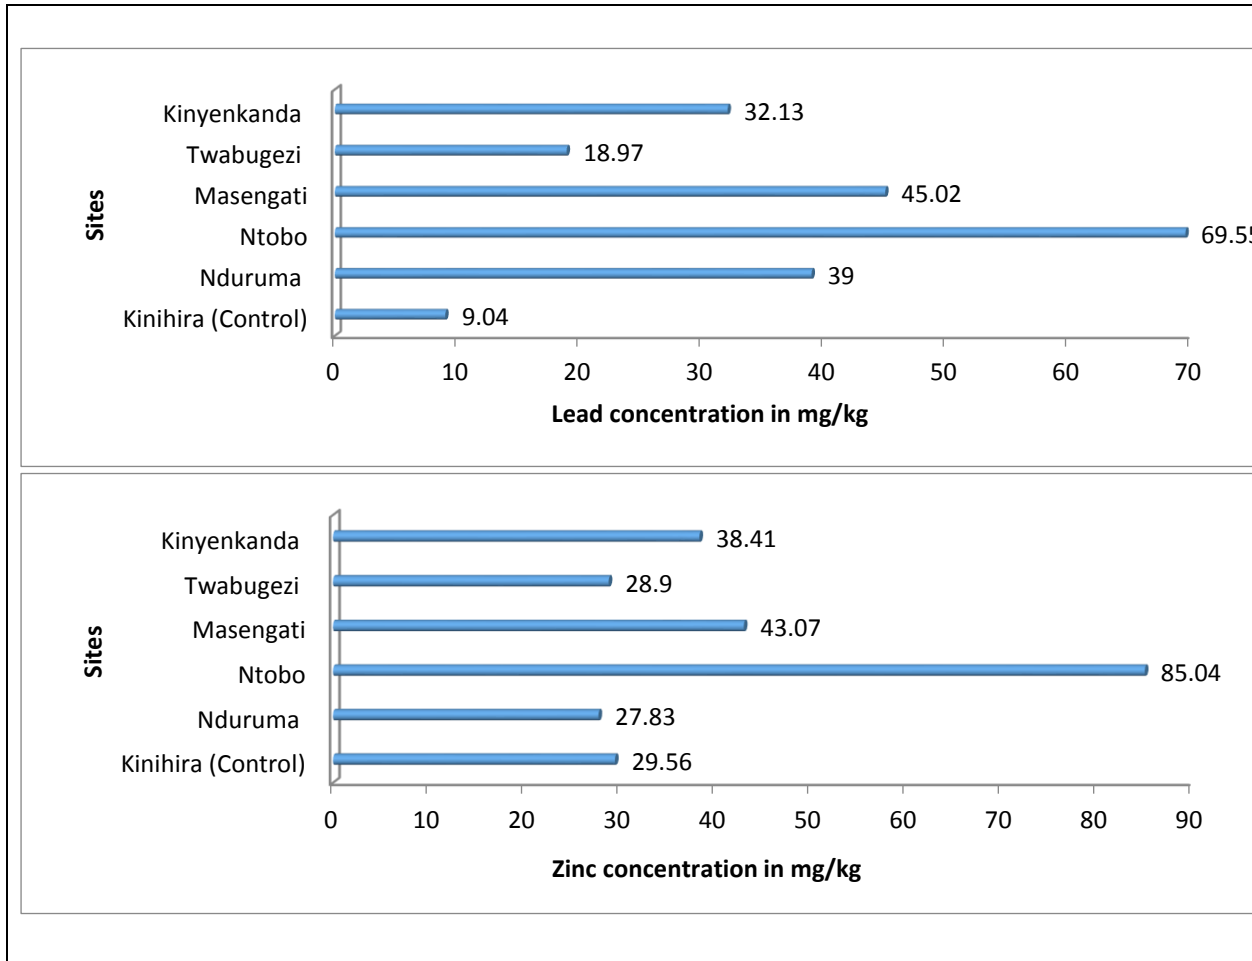
The figure below shows that the lowest lead (Pb) concentration of 9.04 mg/kg was measured at Kinyihira while the highest of 69.55 mg/kg was seen at Ntobo site followed by Masengati with 45.02 mg/kg. The measured Pb concentration at Nduruma and Kinyenkanda were 39 mg/kg and 32.13 mg/kg respectively while it was 18.97 mg/kg. This reveals that the Pb concentration measured at Ntobo is the only one that is closer to considered as the worldwide standard lead

Figure 16: Lead (Pb) and Zinc (Zn) concentration in sampled soil

As for Lead, Zn concentration at study area culminates at Ntobo site with 85.04 mg/kg and it decreases almost to the half at Masengati (43.07 mg/kg) to become 38.41 mg/kg at Kinyenkanda. The remaining sites of Twabugezi, Nduruma and control area (Kinihira) have almost the same Zinc concentration of 28.9 mg/kg, 27.83 mg/kg and 29.56 mg/kg respectively. Though Ntobo site has the highest Zinc concentration, it is far below the world standard concentration of 220 mg/kg, obviously lower than Canada, German, Austrian and European standards (Table 5). This implies that the content of Zinc at mining areas is not yet harmful to plant and animal life but the value observed at Ntobo site stands as an alert.

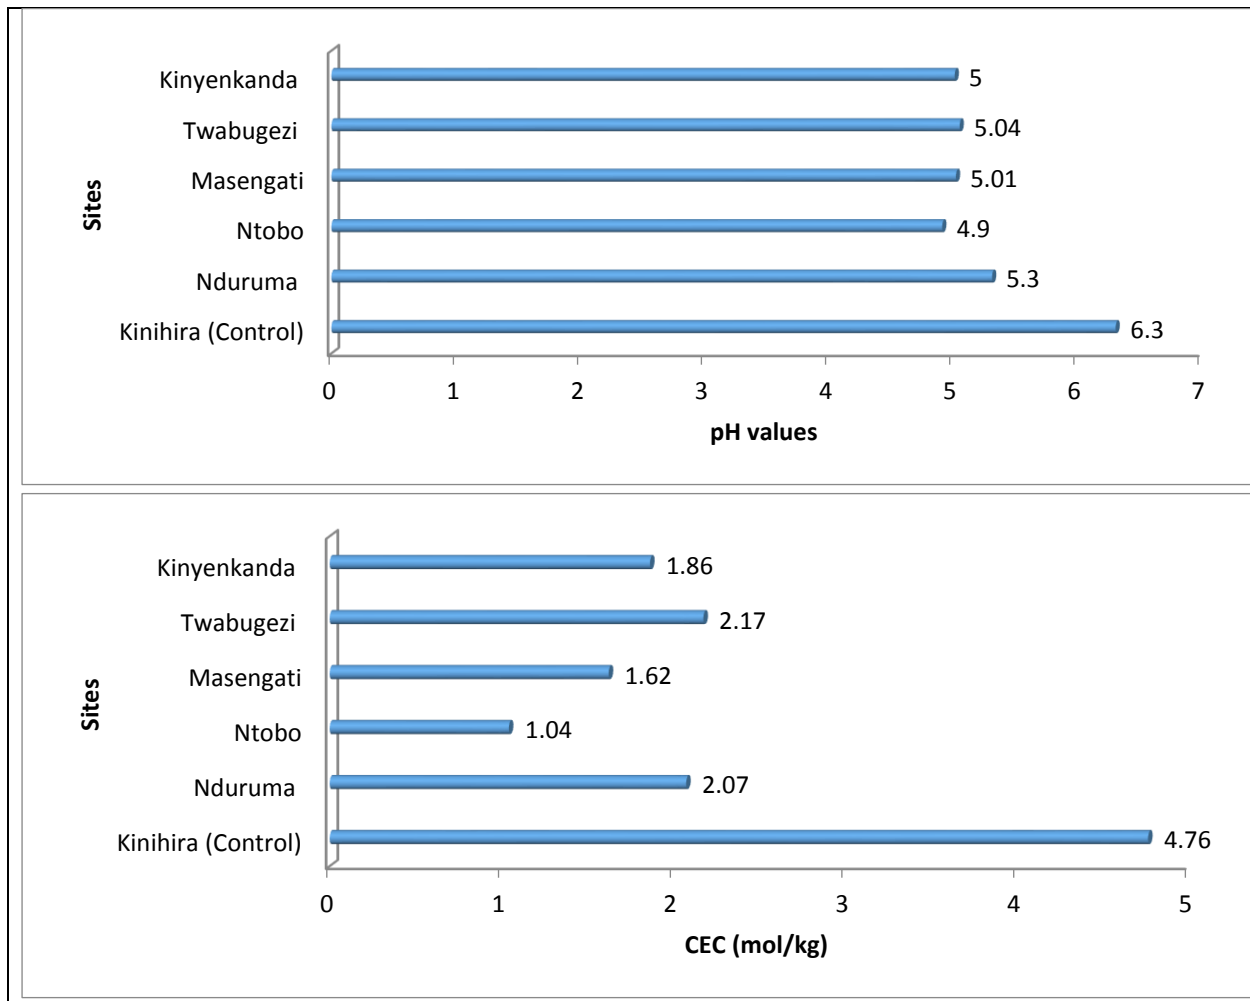
Figure 17: pH values and CEC of sampled water

The study area is covered by acidic soils as far as all sampled mining sites are present soils with pH oscillating around 5 (between 4.9 and 5.3). However, the soils collected from control area (pH 6.3) are still acidic though are nearer to the neutral. This means that mining activity has contributed to soil acidification. As such, many plant species will hardly grow and only adapted plant species can grow in mining areas of Gishwati as consequence of the decline in availability of nutrients and minerals necessary for plant growth.

The study revealed that CEC at mining areas varies between 1.04 mol/kg at Ntobo and 2.17 mol/kg at Twabugezi while it rises up to 4.76 mol/kg at control area (Kinihira). This shows that mining tailings are poor in CEC. These results inform that soils covering the mining areas would be less fertile and less productive because they have little essential mineral content.

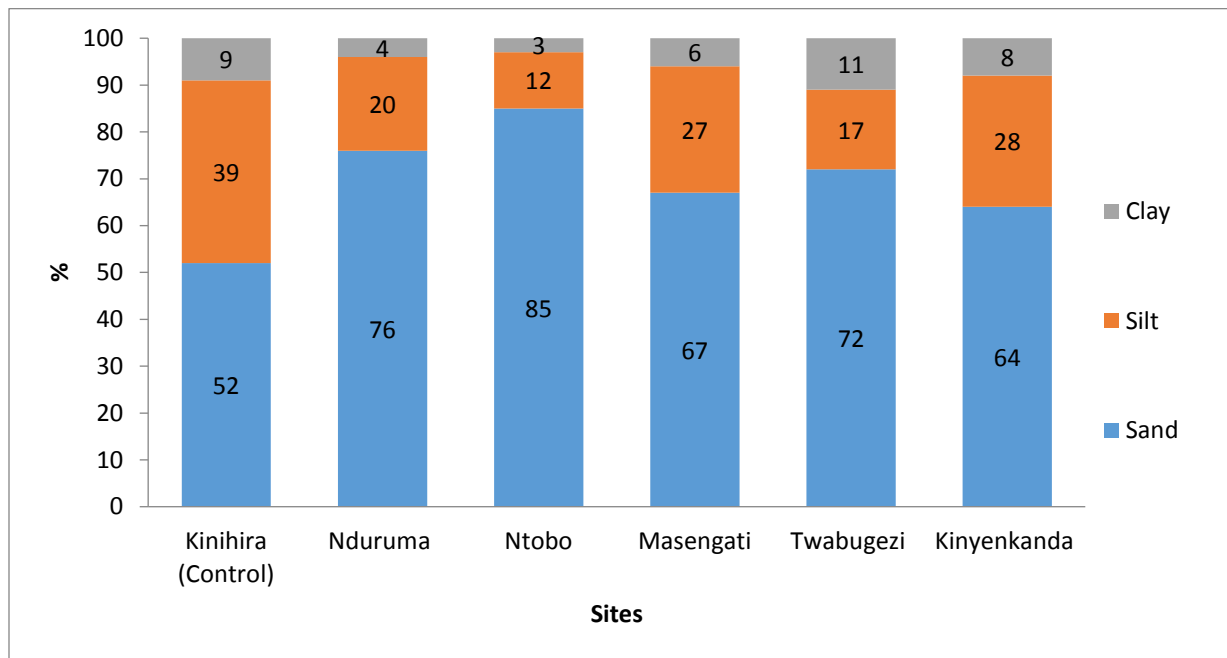
Figure 18: Texture of sampled soils

The figure above depicts that most of sampled soils are dominantly composed of sand especially at Ntobo which are sandy at 85%, followed by Nduruma with 76% and Twabugezi with 72%. Soils from Masengati, Kinyenkanda and Kinihira (control area) contain 67%, 64% and 54% of the sand respectively. A part from Twabugezi's soils which have 11% of clay, the remaining soils contain less than 10% of the clay while the portion of silt varies between 12% at Ntobo and 28% at Kinyenkanda with maximum of 39% at control area of Kinihira. Therefore, the mining tailings contain more sand and less clay. Hence, it can be concluded that the mining tailings are composed by sandy soils which may result into high rate of infiltration with low water retention in the upper part of the soil. This soil will not be conducive for many plant species, hence reduced vegetation cover in the studied sites.

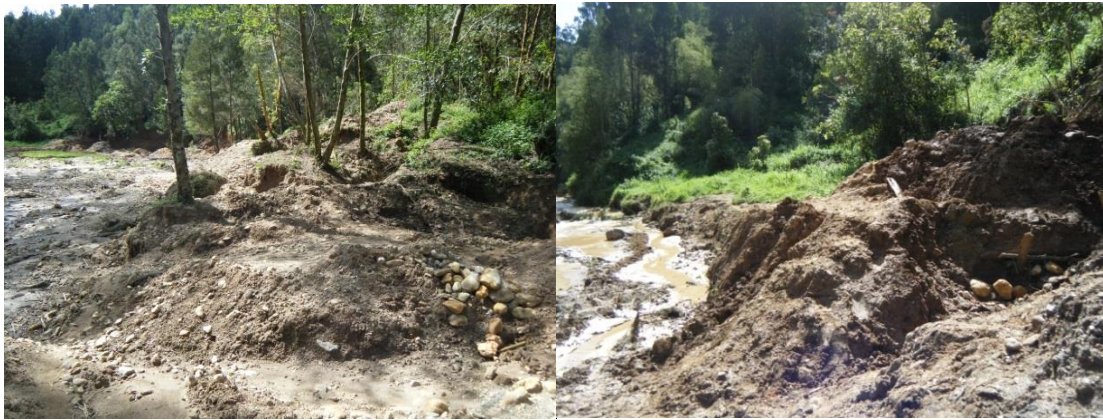
The impact of mining on vegetation was assessed through direct observation, photograph and plant diversity analysis. The impact observed on each site is that mining contributed to the destruction of the vegetation. The most vulnerable types of plants are grasses and herbs. Large open pits lead to the removal of tree species. Overall, the vegetation cover decreases as mining activities invade more and more space. This was more obvious at Nduruma site where mining activity contributed to the destruction of the trees, threatening the protected area of Gishwati forest (Figure 18).

Figure 19: A photography showing a destruction of vegetation at Nduruma site

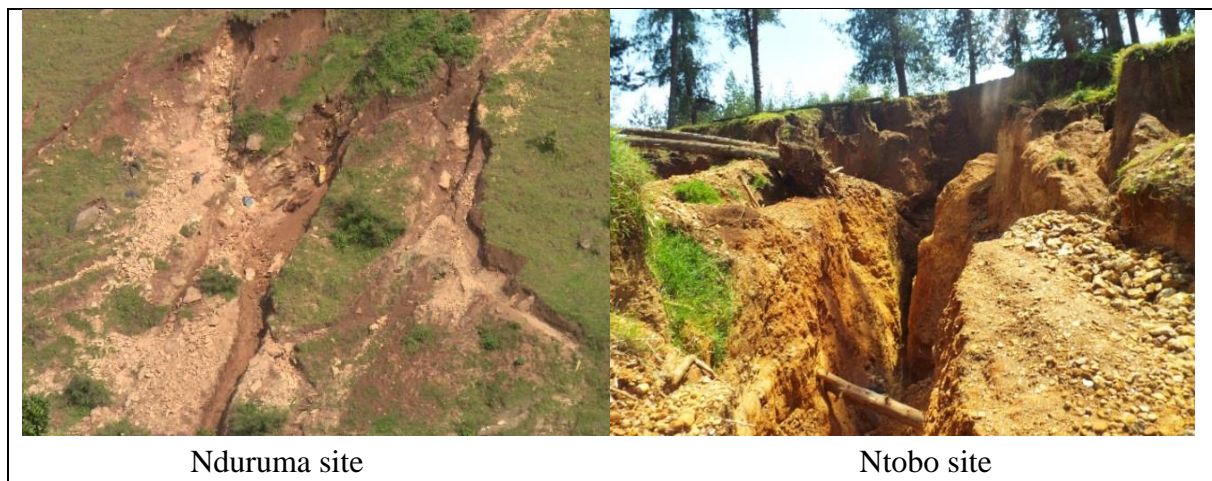
- (i) **Rills and gullies:** They are formed by surface run off at mining sites. Piping water used in course of filtering minerals through sluicing has likely played a significant role in the development of these features. These rills resulted also from the created water channels which were further enlarged with fluvial erosion and developed into gullies. This process can ultimately lead to the formation of badlands (Byizigiro & Biryabarema, 2008).

Figure 20: Photographs showing rills and gullies resulting from piping water

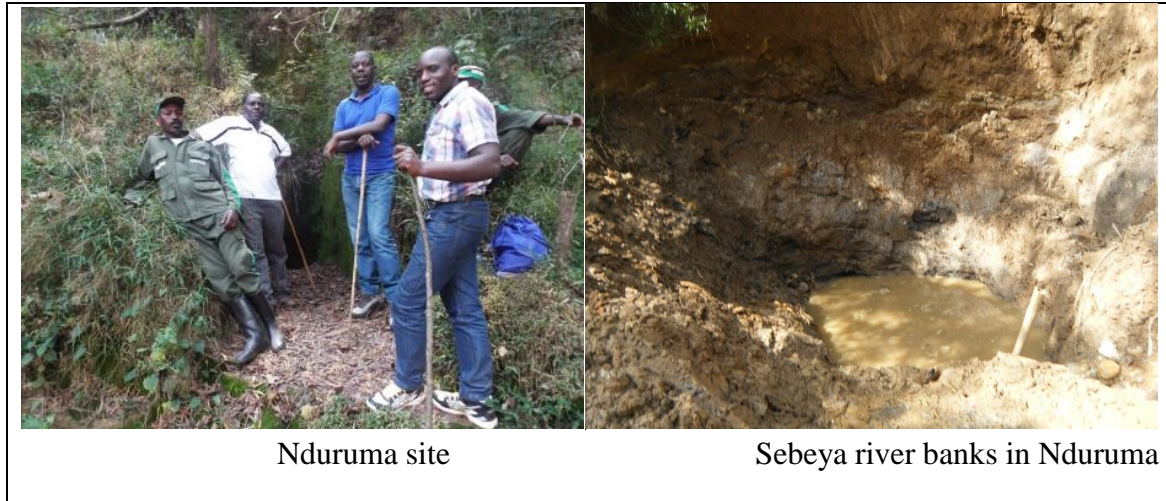
**(iii) Scars:** They occurred upslope of mine pits, from which displaced material has been removed to constitute a ‘remaining landform’ known as ‘crown’ (Westerberg & Christiansson, 1999). Inside the forest, deep pits may also constitute unwanted traps for mammals including primates living in Gishwati forest area.

Figure 23: Scars at mining areas
